## ORBITER PROCESSING FACILITY SERVICE PLATFORM FAILURE AND REDESIGN

Jesse L. Harris\*

THE MISHAP

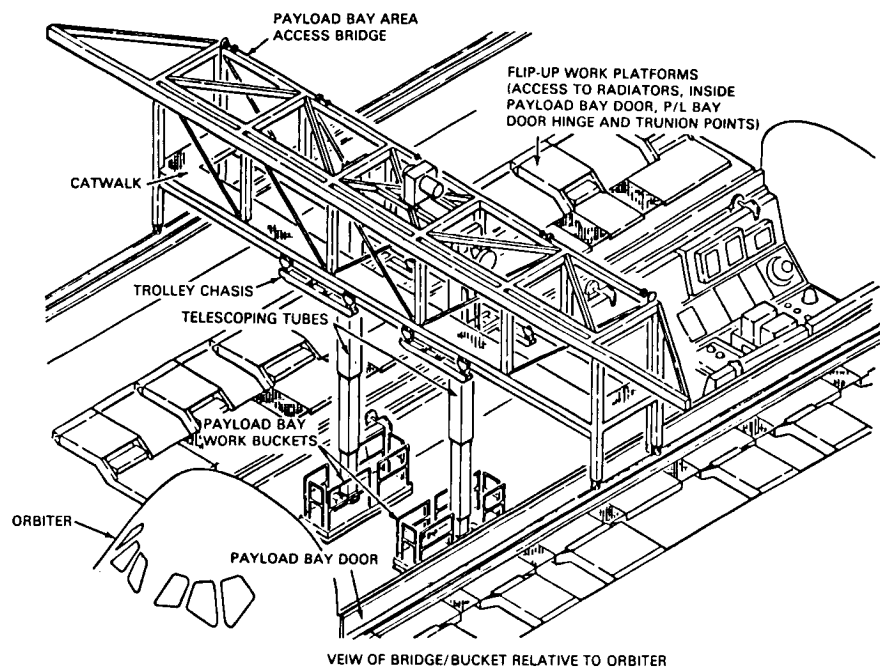
Figure 1

The OPF Bucket system, Figures 1 & 2, consists of a pair of work platforms, telescoping tube assemblies, hoisting systems, and trolleys, both suspended from a common overhead bridge. Each orbiter payload bay may be accessed by two separate bridges, for a total of four Buckets per high bay.

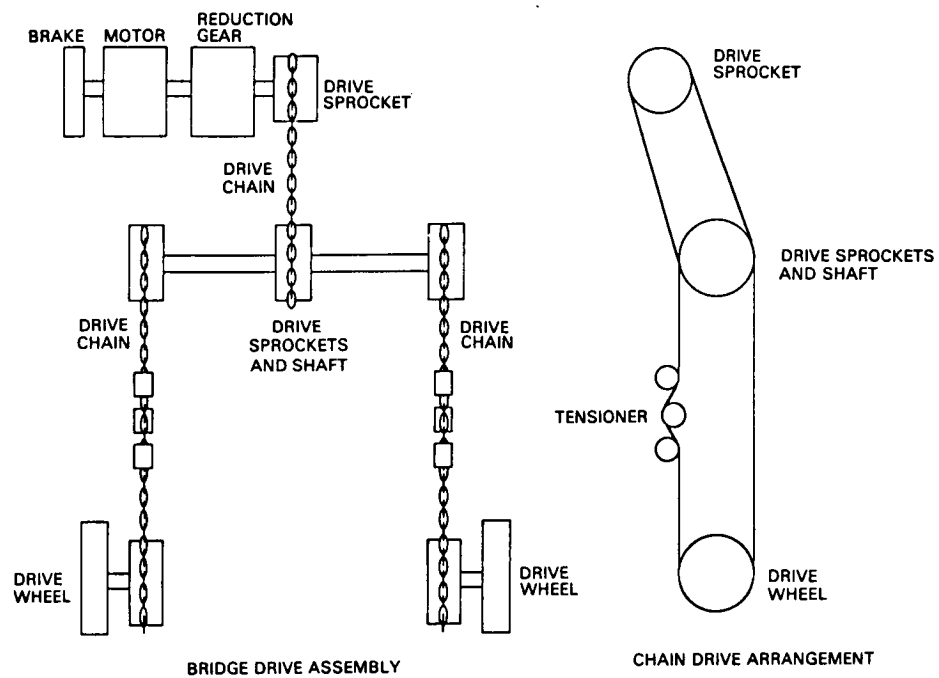
Figure 6

THE BRIDGE is a steel truss which supports two trolley/Bucket assemblies and provides the forward/aft motion capability of the system. The electric drive motor and gear box are centrally located on top of the truss, connected to drive shafts running to each end of the truss; chain drives connect the drive shafts to the drive wheels, Figure 6. The
